Rottnest Island Authority

Annual Drinking Water Report

*July 2021 – June 2022*

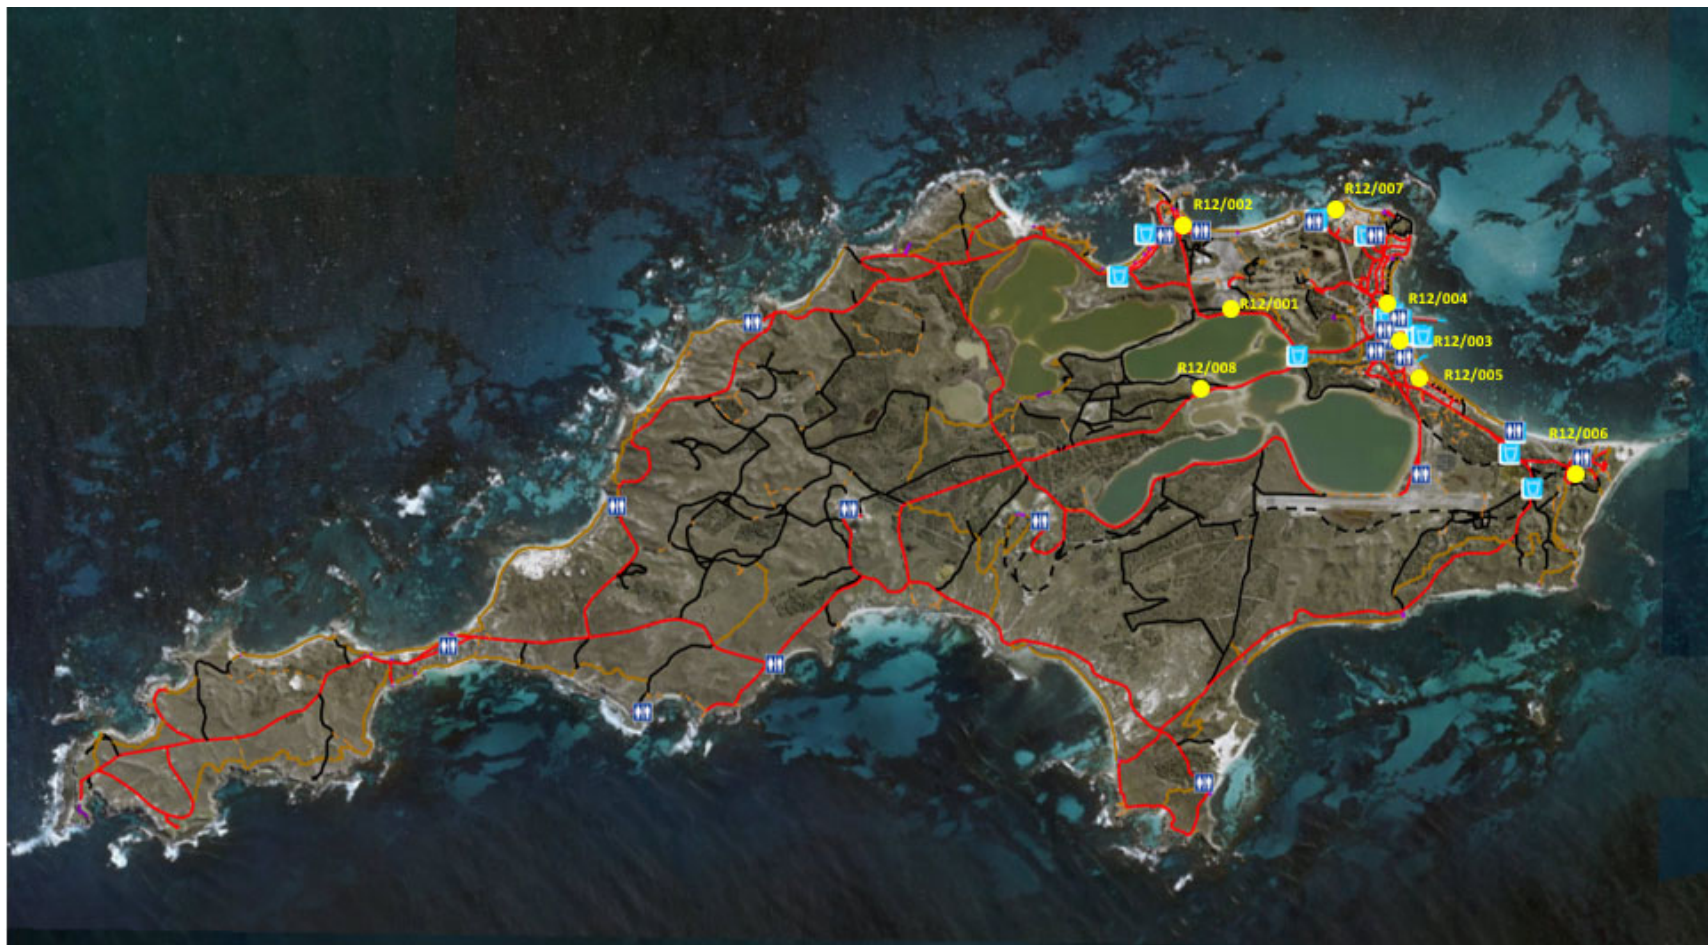
**Figure 2:** Map of the Sampling Locations

The sampling locations are shown in **Figure 1** and **Figure 2**.
