**Quarterly Drinking Water Report
to the
Department of Health**

1 October – 31 December 2025

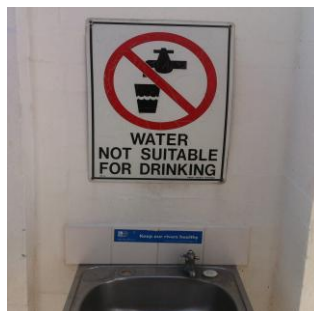
Figure 1 Example of Public Signage

Remote locations outside the main settlement, such as the outer island ablutions, Wadjemup Lighthouse and surrounding area, are supplied with water via a tanker. The supplied water in these areas is deemed not suitable for drinking and warning signs are posted accordingly.
