**Quarterly Drinking Water Report  
to the  
Department of Health**

**1 January – 30 March 2026**

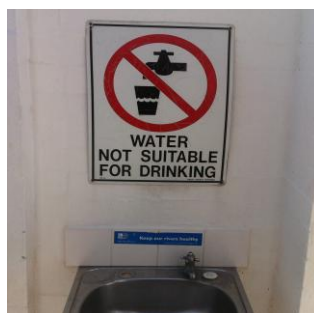
*Figure 1 Example of Public Signage*

Remote locations outside the main settlement, such as the outer island ablutions, Wadjemup Lighthouse and surrounding area, are supplied with water via a tanker. The supplied water in these areas is deemed not suitable for drinking and warning signs are posted accordingly.
